IN THE MIDST OF A LONELINESS

THE ARCHITECTURAL HISTORY OF THE SALINAS MISSIONS

Salinas Pueblo Missions National Monument Historic Structure Report

Professional Papers No. 15

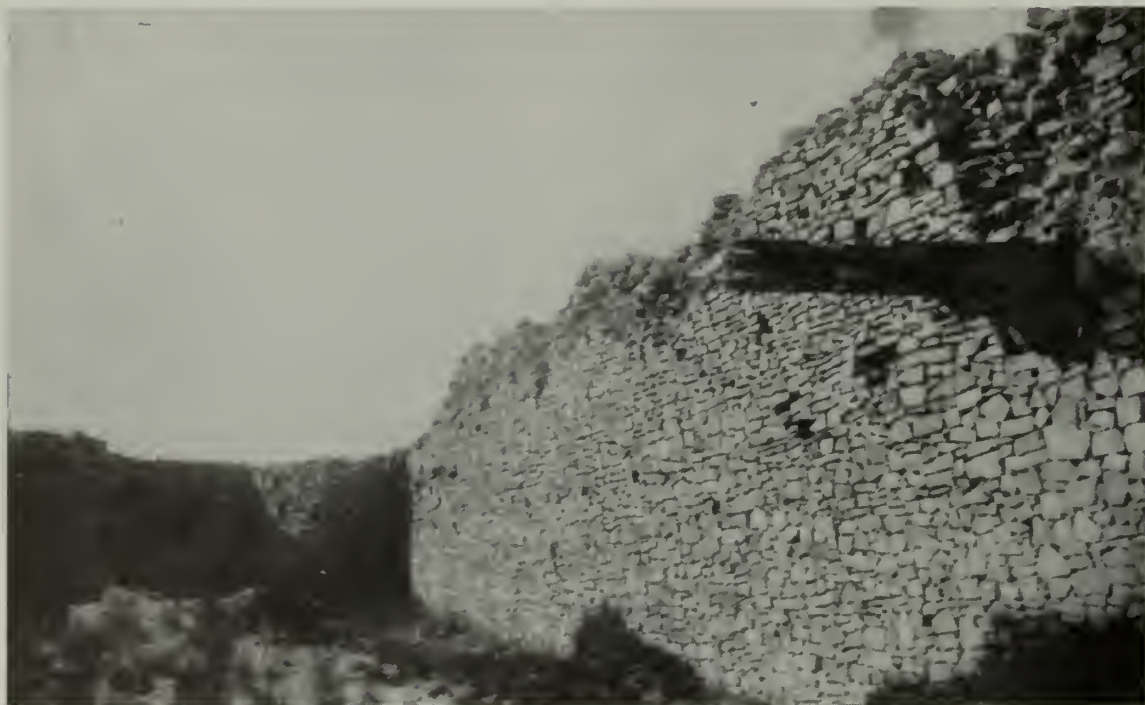
Figure 40. The interior of the church of San Buenaventura as Bandelier saw it in January, 1883. The right stub of the viga that formed the main support for the choir loft, and its corbel, are both still set into the north wall. These are the same corbel and viga sketched by Morrison in 1877. The entablature running from the viga to the front wall of the church, however, has been removed. The rubble fill against the walls in the nave of the church is only 1 1/2 to two feet higher than the present floor surface. Biblioteca Apostólica Vaticana, Archivo Fotografico, # 485-50, courtesy Charles Lang.

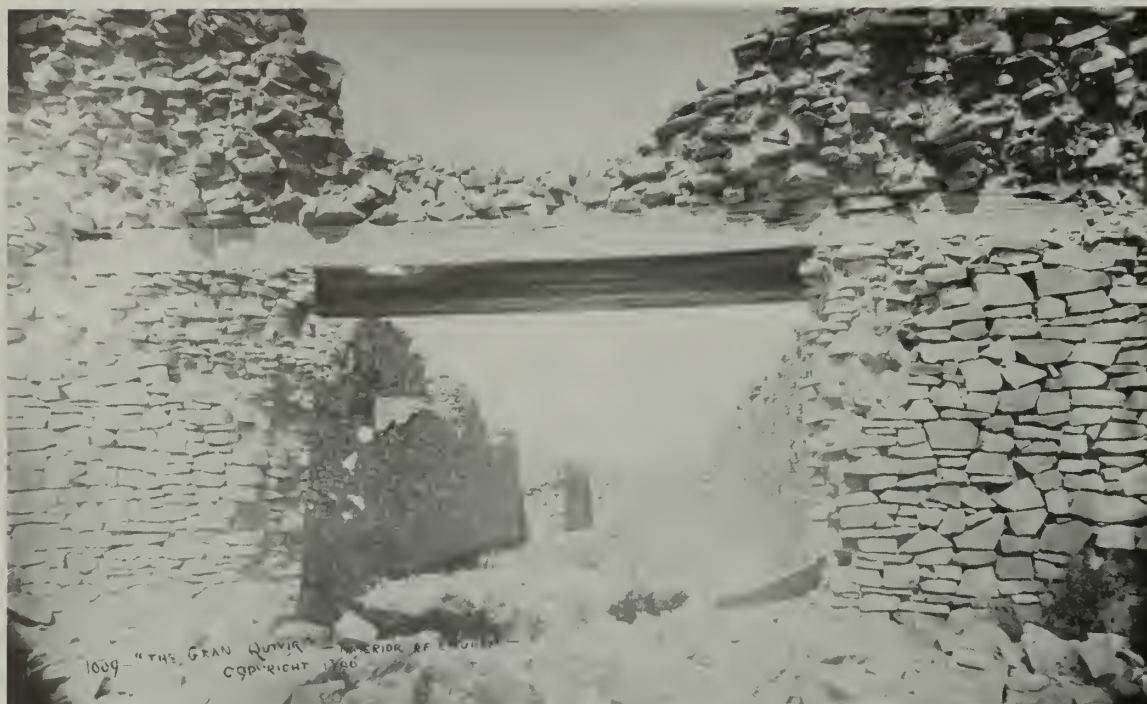
Figure 42. The interior of the church of San Buenaventura in 1890. Lummis photographed the south end of the main viga that supported the choir loft, with its corbel, and the outside of the lintel over the front door of the church. It was this photograph that allowed the identification of the beam presently over the door as the beam closest to the camera in the lintel, by the distinctive pattern of knots and cracks. Courtesy Southwest Museum, # 24825.

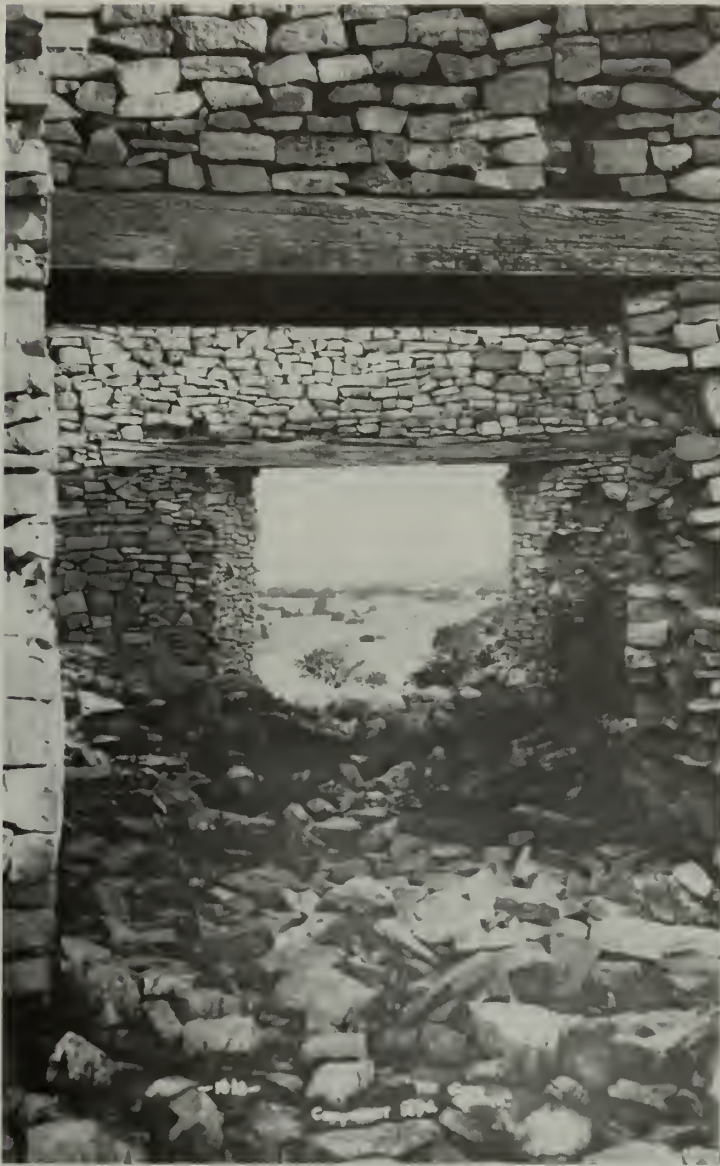
Figure 43. The doorway from the church of San Buenaventura into the sacristy in 1890. This photograph by Lummis shows the decorative carving on the beam over the doorway, and the appearance of the sacristy window. Courtesy Southwest Museum, # 24836.

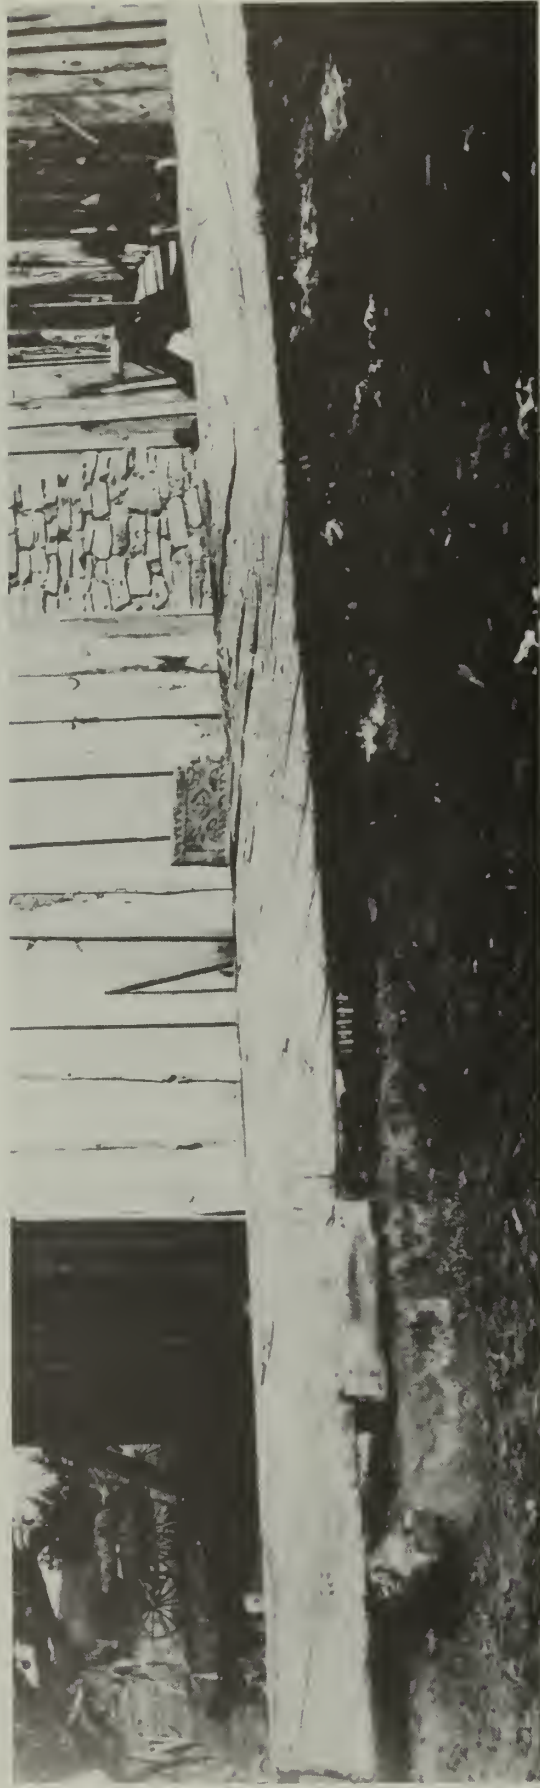
Figure 45. A beam from San Buenaventura. It was photographed in 1896 in front of a shed of the Dow House next to the post office of Gran Quivira. This beam has decorative carving on the middle section of the face towards the camera. The carving, cracks, and weathering all match the details of the beam in the engraving in the previous illustration, making it very likely that this beam had been removed from the inner face of the facade of San Buenaventura between 1890 and 1896. Courtesy National Park Service, #GQ-448.

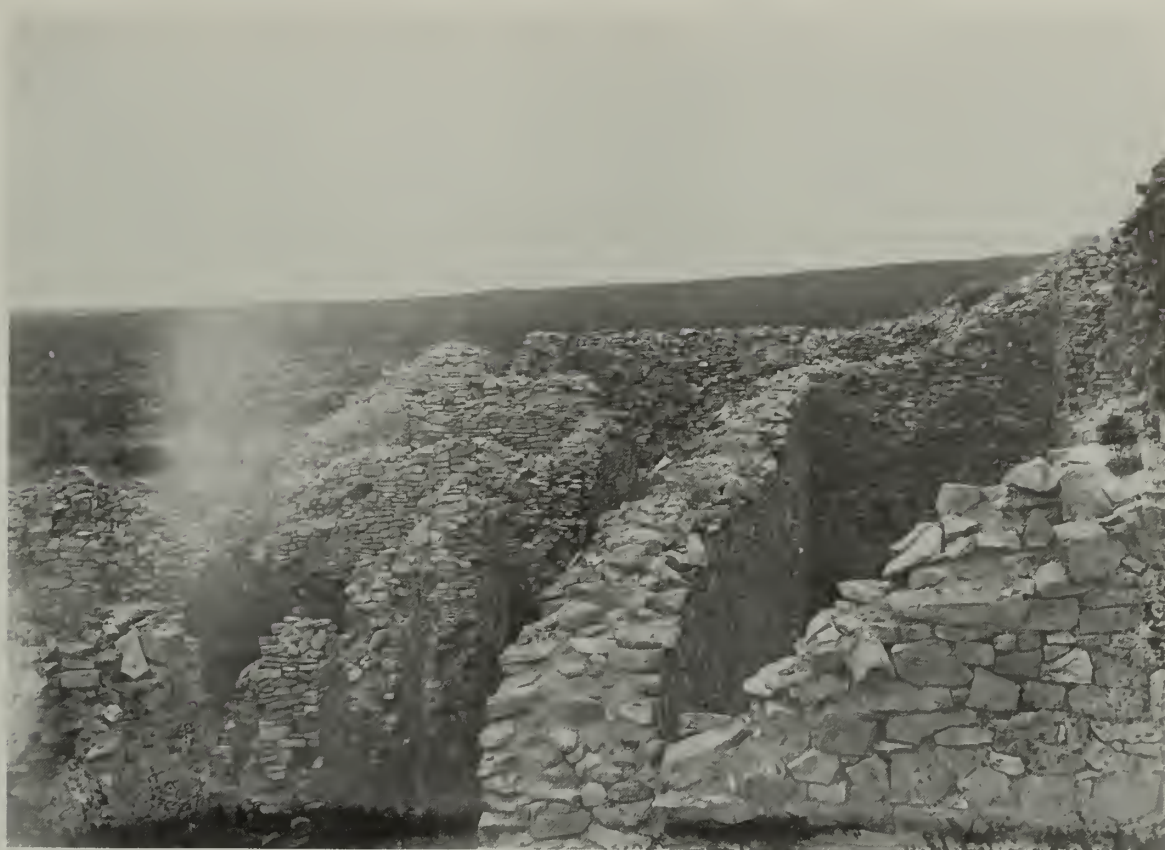
Figure 46. The north portion of the convento of San Buenaventura about 1900. The room at the right is room 16, and the north corridor runs diagonally across the center of the picture to the sacristy in the background. This photograph is of great importance, because it records the last surviving traces of the roof of the convento. Six beam sockets can be seen in the top of the wall between the sacristy and room 15. The second socket from the left still has the stub of a beam set in it. The sockets and beam stub survive here because the thickness and height of the sacristy wall kept it from collapsing to a level below the beam sockets of the convento, as happened everywhere else in the convento except along the south side of the church. The sockets in room 15 were about 10 feet above the present floor level, three feet lower than the sockets in the south wall of the church in rooms 1 and 16. Courtesy New Mexico State Monuments, # 40667.

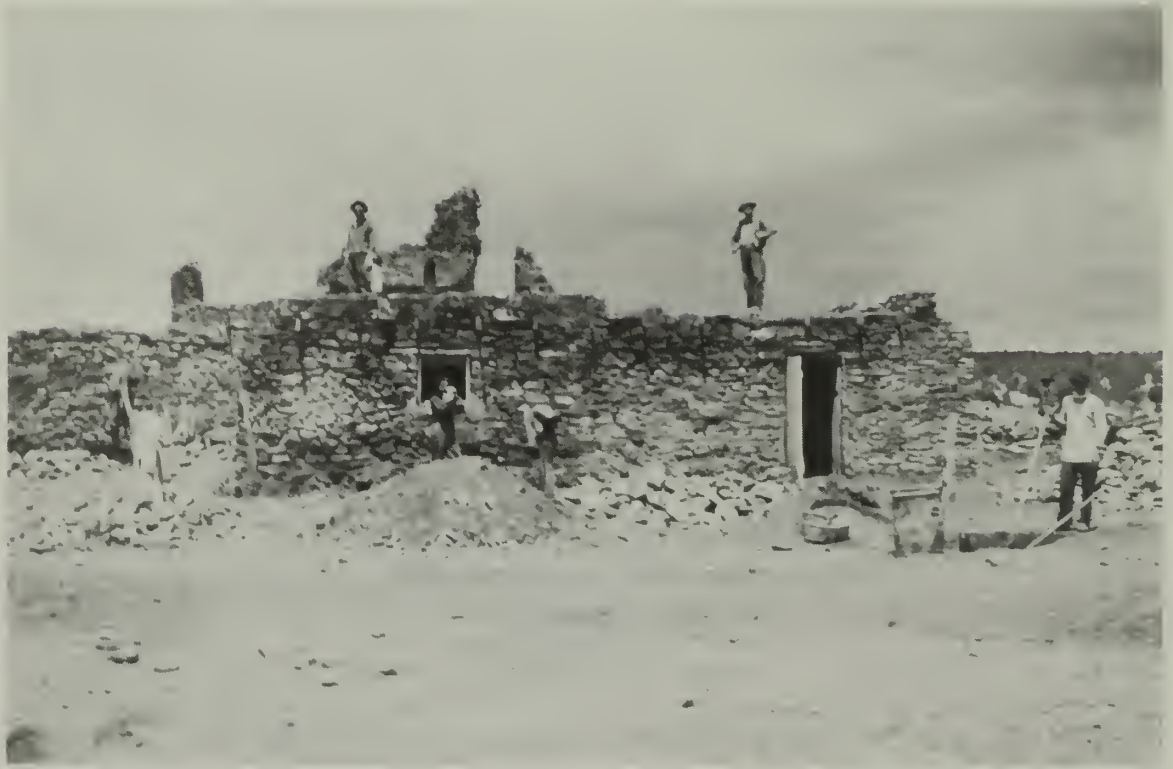
Figure 47. The Marcos Luna house at Abó. It is being converted to a toolshed by workmen under the direction of Joseph Toulouse about June 28 or 29, 1938. The Luna house can be seen in earlier photographs taken at a distance from the church, but only the lower few feet of walls still stood at the time. In 1882 Adolph Bandelier drew its outline on his map of the ruins of the pueblo of Abó, along the east edge of the mounds left by the collapse of the convento. Toulouse raised the walls by about 5 feet and added doors, windows, a roof, and a fireplace. The entire building was removed in late 1939 as part of the final cleanup of the area. Courtesy Museum of New Mexico, # 45415.

The first priorities were to fence the site to protect it from vandals, and to build a storeroom to protect the tools and equipment left on the site overnight and on weekends. The fencing work proceeded slowly and was not completed until late in the year. Toulouse elected to rebuild several rooms of the ruins of the Marcos Luna house and use it as his toolroom. Work on the reconstruction of the rooms was completed by June 30. Later, in 1939, Toulouse demolished the toolroom and all other traces of the Luna house that he could recognize.

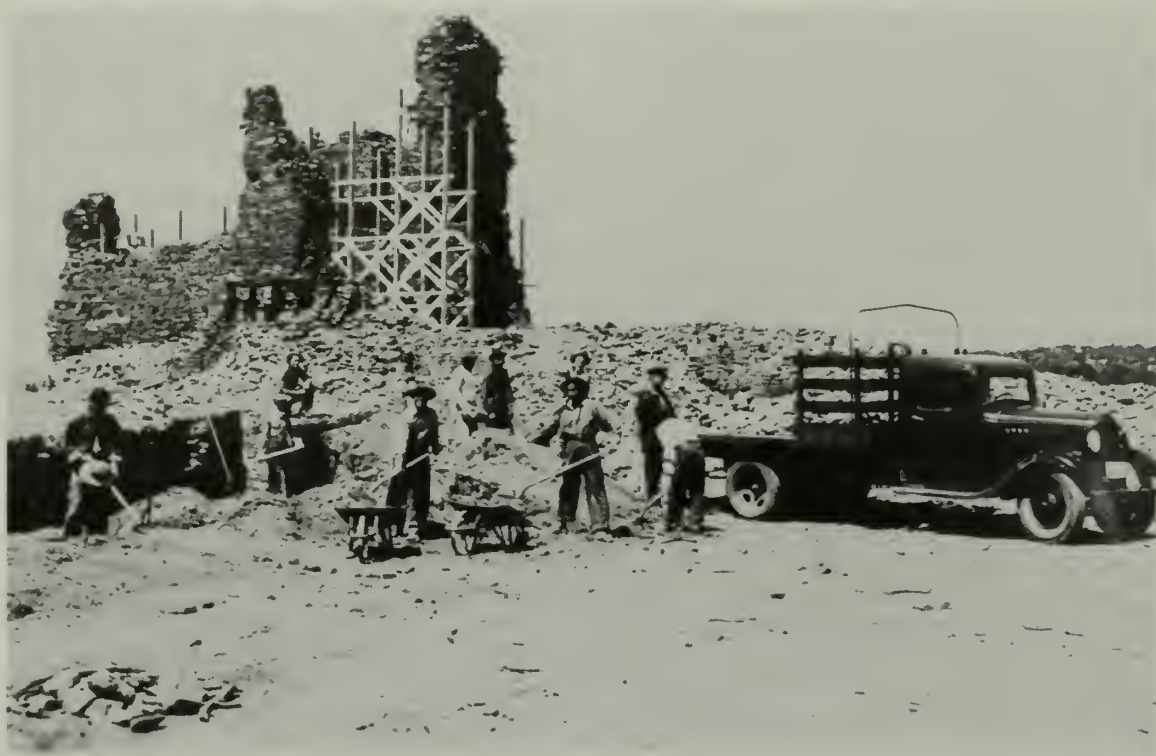
Figure 48. Stabilization and excavation of Abó by Joseph Toulouse, 1938. The photograph was taken in the last week of July or the first week of August. In the foreground, a crew is clearing rubble away from the north wall of the convento in the process of tracing the wall face outside rooms 13, 14, and 15. In the background, the scaffolding for the masons stabilizing the west wall is visible on the inside and outside faces of the wall, but no work has started on the north end around the bell tower. Courtesy Museum of New Mexico, # 6357.

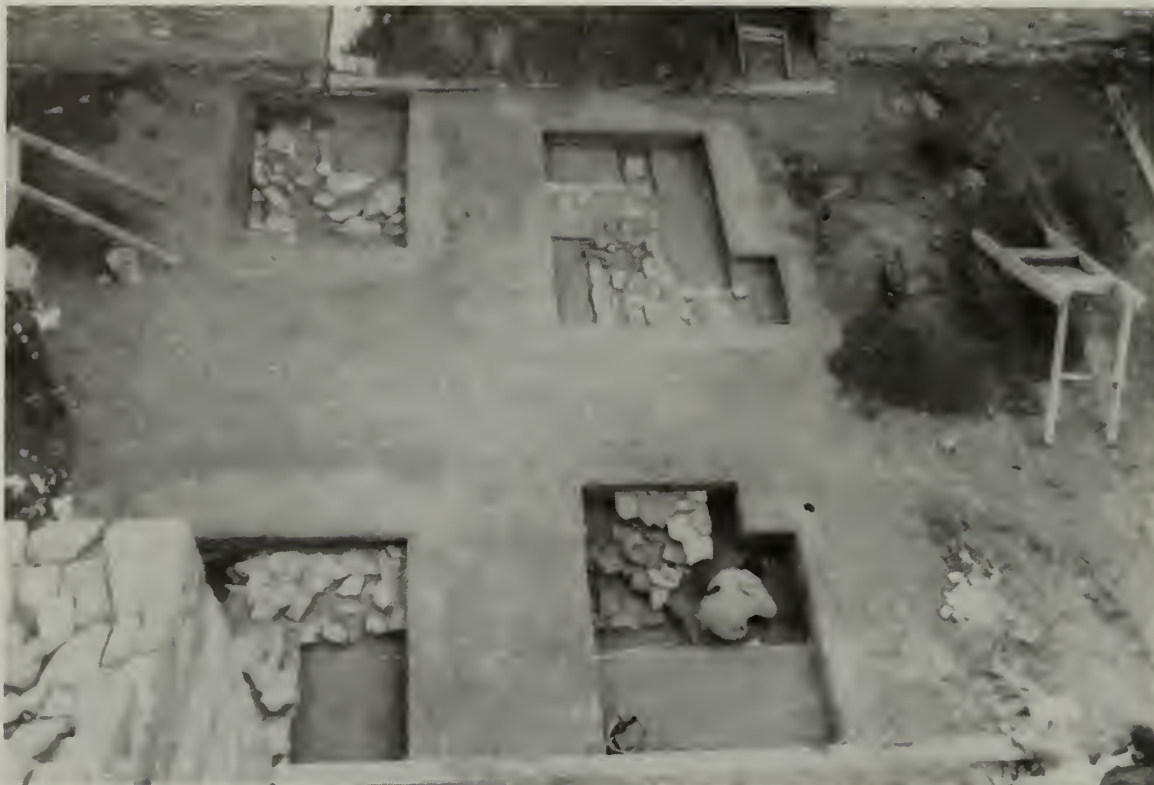
Figure 49. The first church of San Gregorio de Abó. This photograph, taken during excavations in March, 1987, shows the walls outlining the apse of the church.

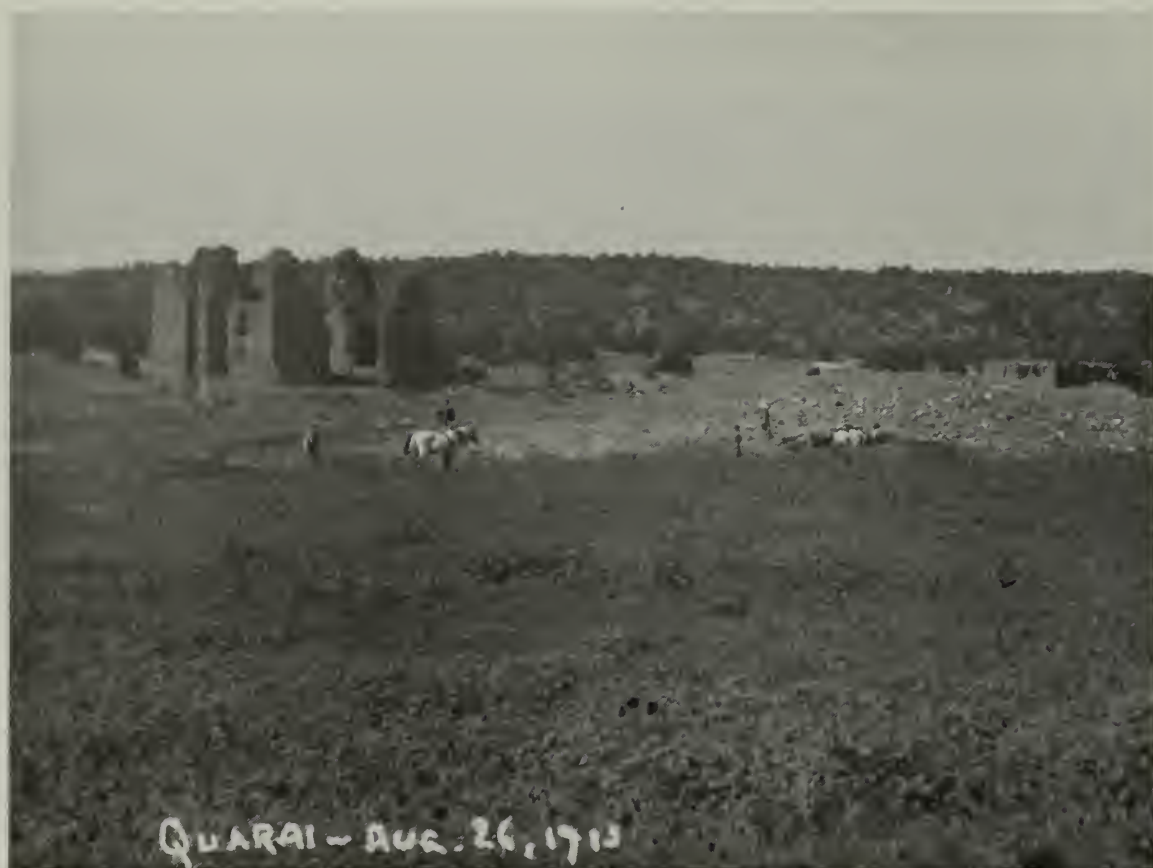
Figure 50. Quarai on August 26, 1913. In the foreground is Mound A, with the School of American Research excavations in progress. Just above the mound is the Lucero House, showing signs of deterioration on the enclosing wall. The house appears to be just behind the mound, but this is an effect produced by Lummis's camera lens. The walls of the convento have all fallen to within a foot or two of the tops of their rubble mounds, and the east wall of the nave has fallen into the church. Courtesy Southwest Museum, # 24837.

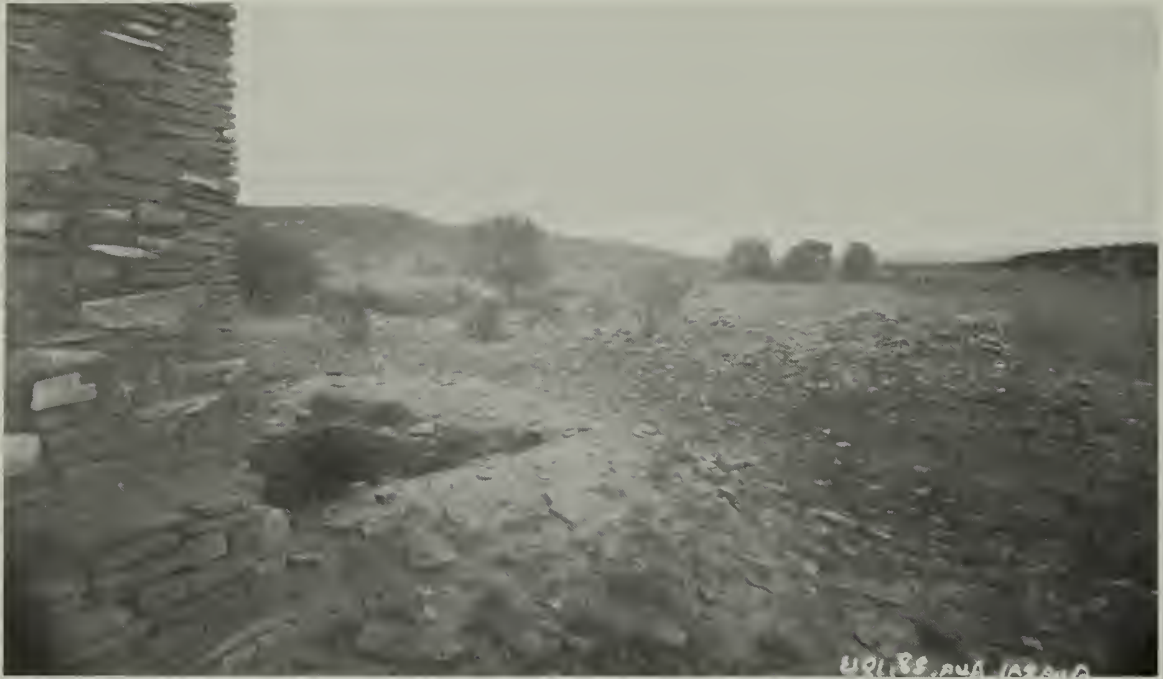
Figure 51. The area of the sacristy of Quarai in 1913. Lummis stood on top of the stub of the wall of room 6 to take this photograph. Just past the corner of the transept, the hole excavated into the sacristy can be seen. In the middle ground the walls of rooms 11, 12, and 13 have all fallen to heights of about one or two feet on the side toward the camera. On the east side, the walls stand four or five feet above the sloping rubble. Courtesy Southwest Museum, # 24838.

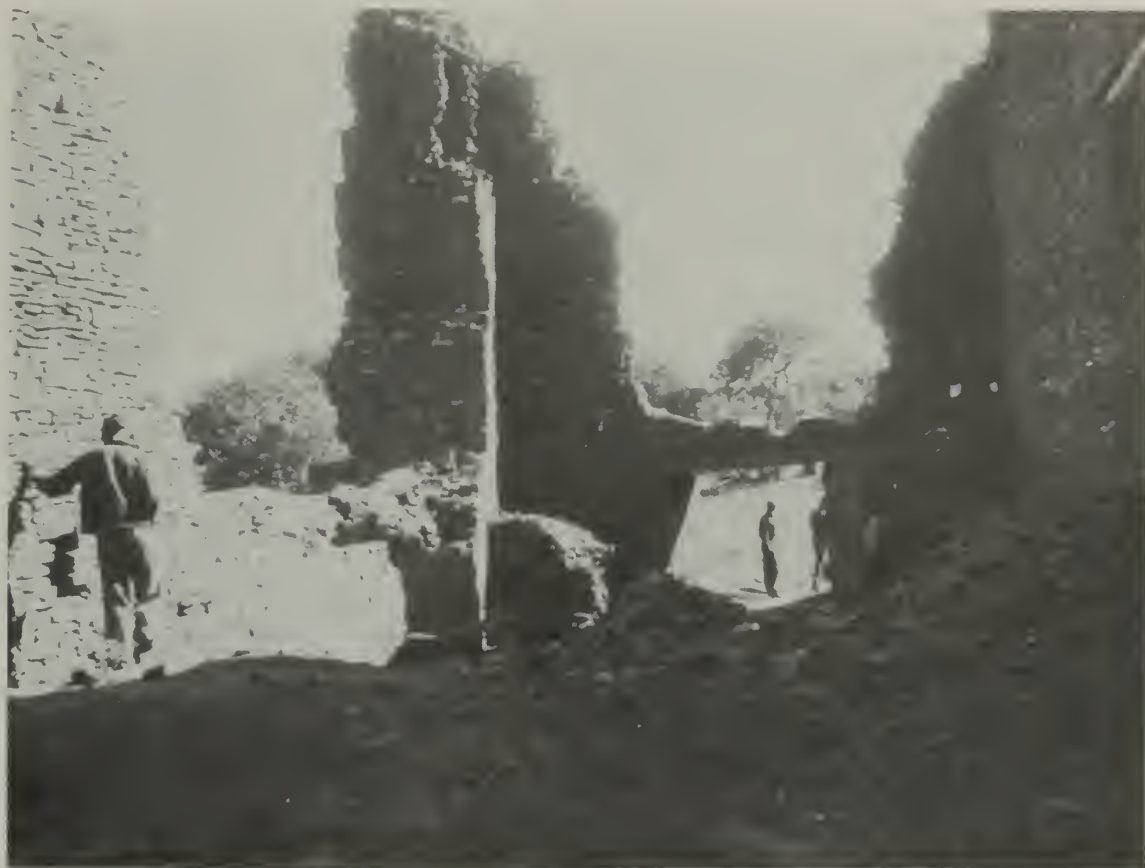
Figure 52. Excavations in the church of Quarai, first week of August, 1934. This photograph was probably made by Donovan Senter. The fill has been emptied from the church for about the first thirty feet on the east side, except for a block left in the southeast corner. On the west side the fill remains to within about ten feet of the front wall. Floor level can be seen at the front door, where the lintel has already been installed about one foot too low. The lintel of the west window of the nave has been reinstalled, and the wall rebuilt above it. Courtesy Museum of New Mexico, # 6676.

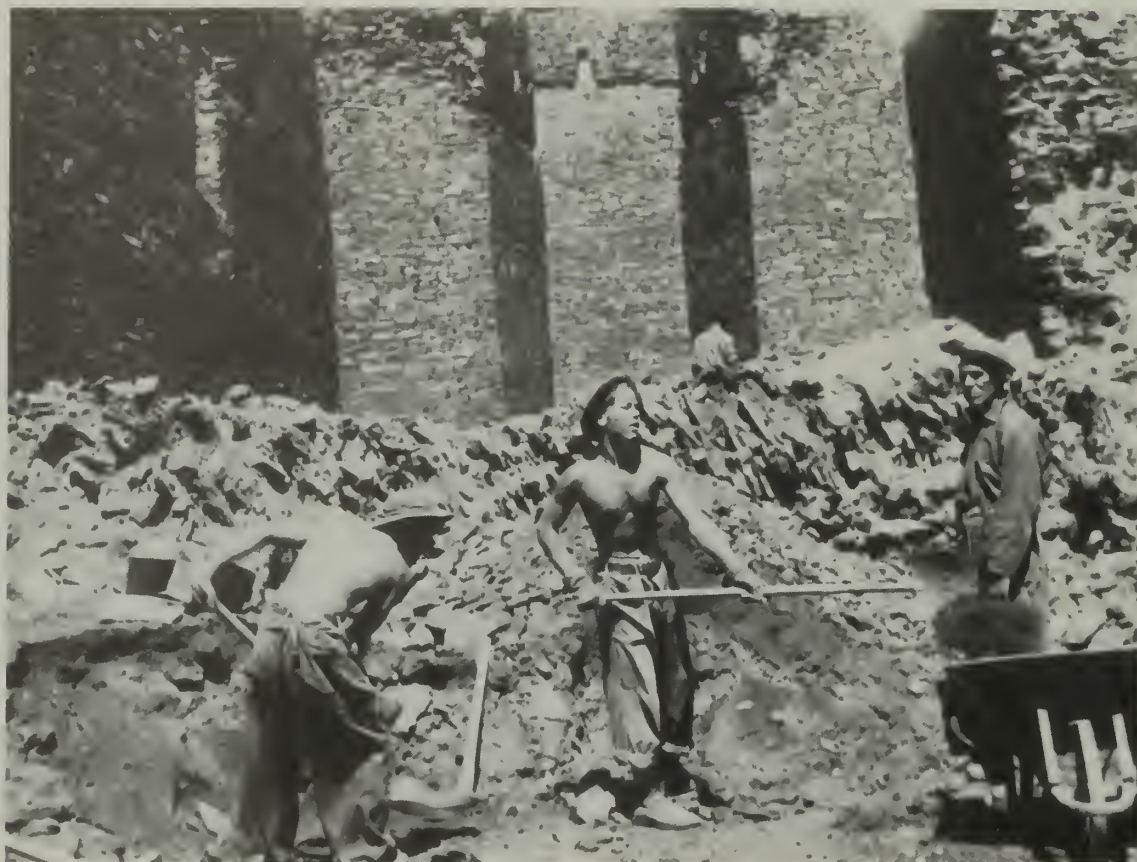
Figure 53. Removing the fill from the nave of Quarai, first week of August, 1934. The fallen east wall of the nave can be seen behind the workmen, with the stones still in approximately their original relationship to each other. The workmen are standing about on the original floor of the church. Courtesy Museum of New Mexico, # 6675.

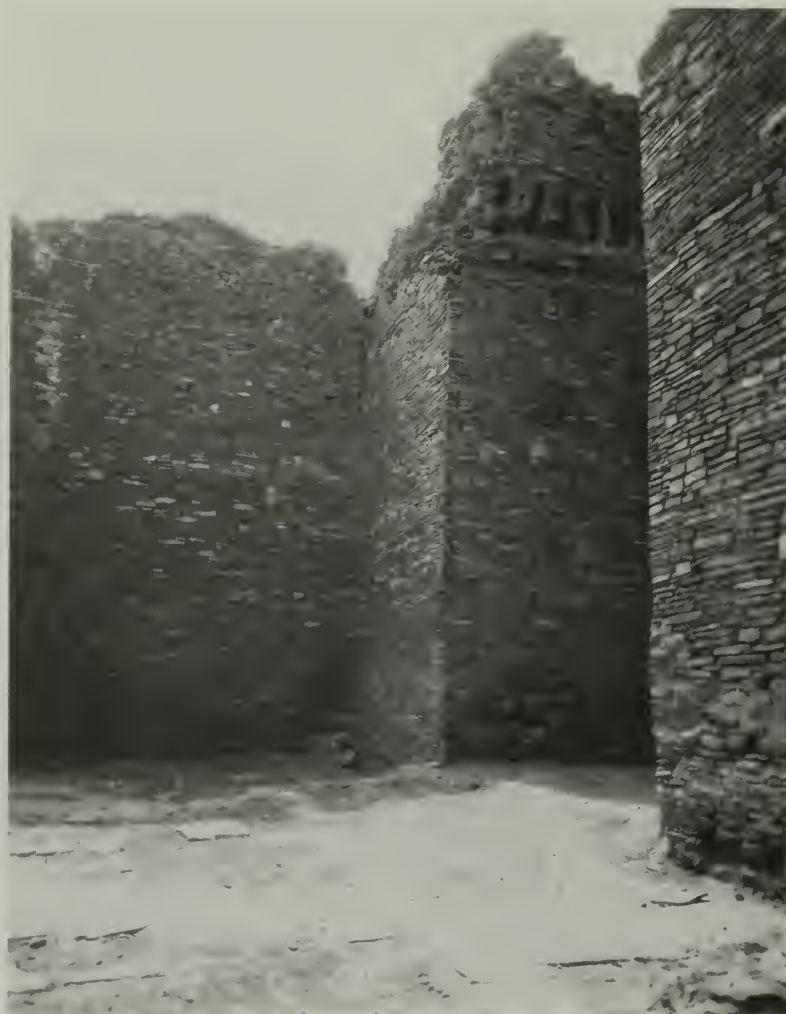
Figure 54. The west transept and apse of the church of Quarai in the fall of 1937. In the northeast corner of the transept the west side altar base still stands, and closer the last traces of the main altar stairs remain at the west side of the apse. The socket for the stair bannister on the corner of the apse has been filled. In the foreground at the lower right corner of the picture, the top of the east side altar base is just visible. The surviving flagstone of the transept can be seen, and the rectangular areas of bare dirt in front of each of the altars. High on the west wall of the transept, patches of white wall plaster can be seen. Some of this patch still survives today. High in the apse the horizontal socket of the retablo support beam runs beneath the sockets of the apse roof vigas. Above these, the severe collapse around the sockets of the transept roof beams is visible. This collapse was caused by the burning out of the main viga that ran across the north face of the transept just under the corbels of the transept vigas. It supported the transept vigas over the mouth of the apse. One description of the same area on the east side of the apse stated that about four feet of the thickness of the masonry had fallen away from around the beam sockets. Courtesy Museum of New Mexico, # 87726.

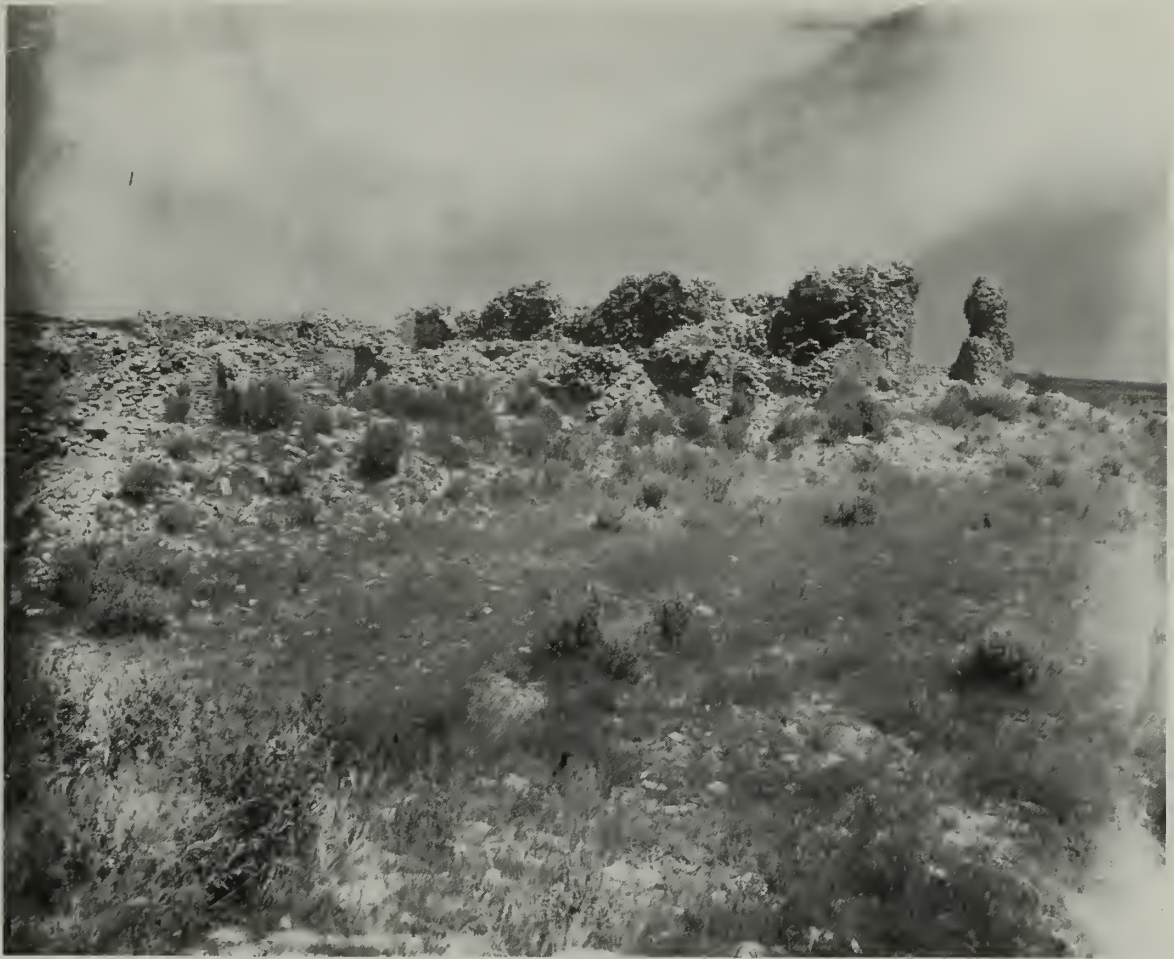
Figure 56. San Buenaventura about 1920, taken from almost the same spot as Bandelier's photograph in 1883. The tremendous loss of wall fabric through the theft or, in a few cases, the decay of lintels, is obvious. Courtesy National Park Service.

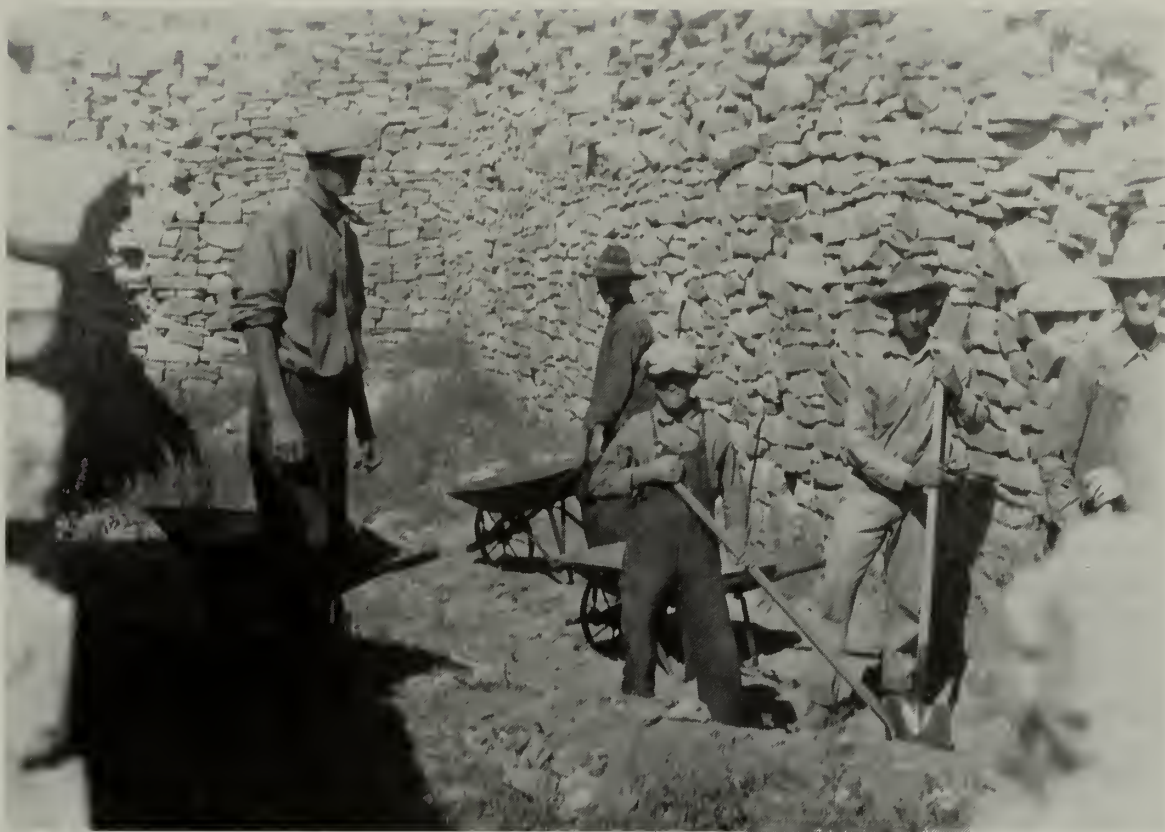
Figure 57. Excavation of the convento of San Buenaventura. This is room 16, probably in the summer of 1927. Courtesy National Park Service.

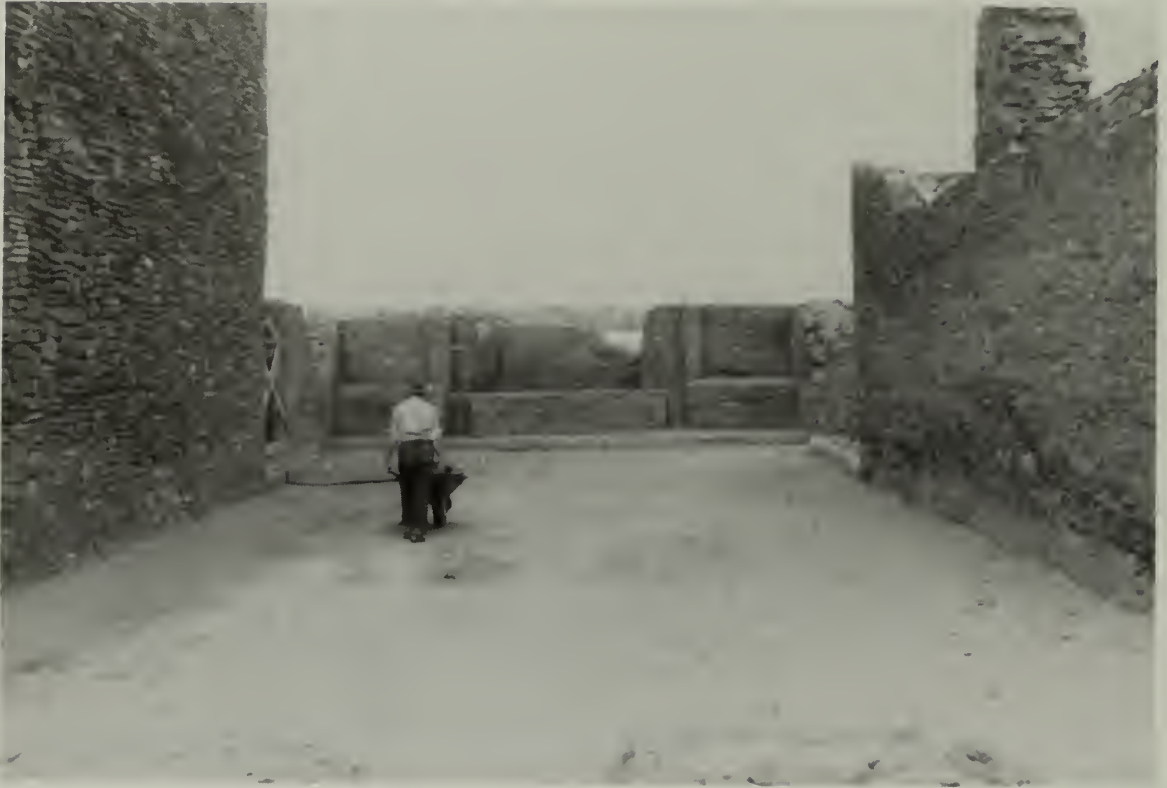
Figure 58. Abó in 1939. The interior of the church in the final stages of cleanup and stabilization. Replacement beams have been cut and set into the floor along the edges of the side chapel altar platforms and in front of the main altars. Stabilization of the side walls of the sanctuary near the side altars has not yet been carried out. Courtesy Museum of New Mexico, # 6365.

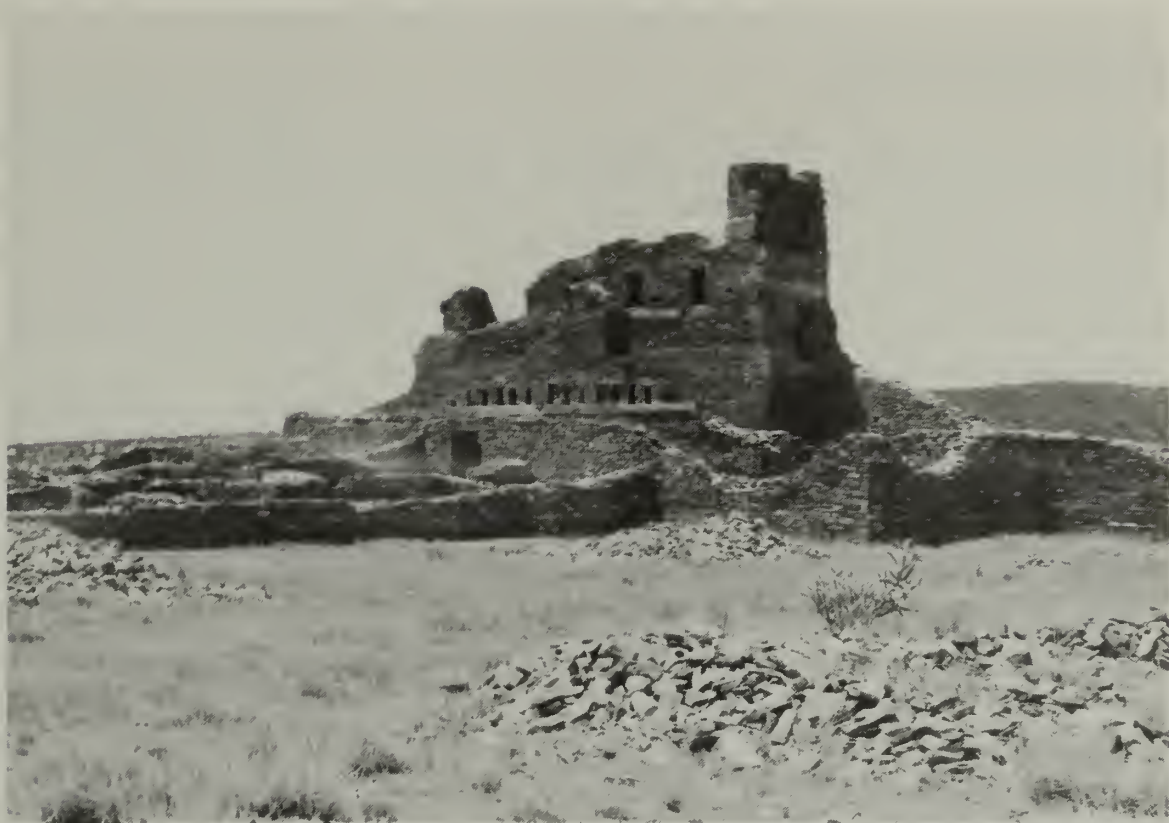
Figure 59. Abó as it appears today. The bell tower area is about 5 feet lower in this picture than in the previous photographs, but its top has been reconstructed to have the same general appearance as it had before the removal of the upper masonry. This demolition and remodelling occurred in 1972. The lower four viga stubs set in the north face of the tower by Toulouse are still in place, as are the viga sections in the east face of the west wall and under the sacristy roofbeam sockets, but the upper pair of viga stubs in the tower are gone, removed in 1958. The wall for the first four feet above the surviving viga stubs is refaced, the result of the work of 1972. Courtesy National Park Service.

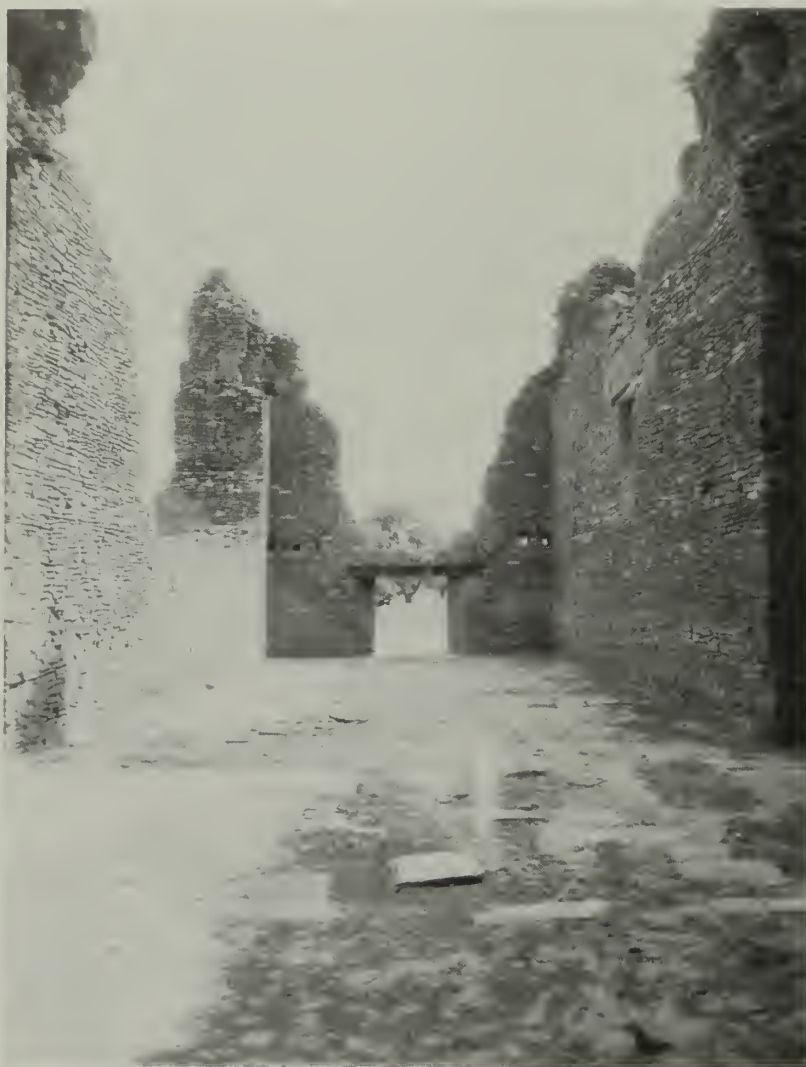
Figure 60. The nave of the church of Quarai in the fall of 1937. The photograph was taken after the completion of the first excavation and stabilization of the building. All of the surviving flagstones of the church floor remain undisturbed. Courtesy Museum of New Mexico, # 87730.

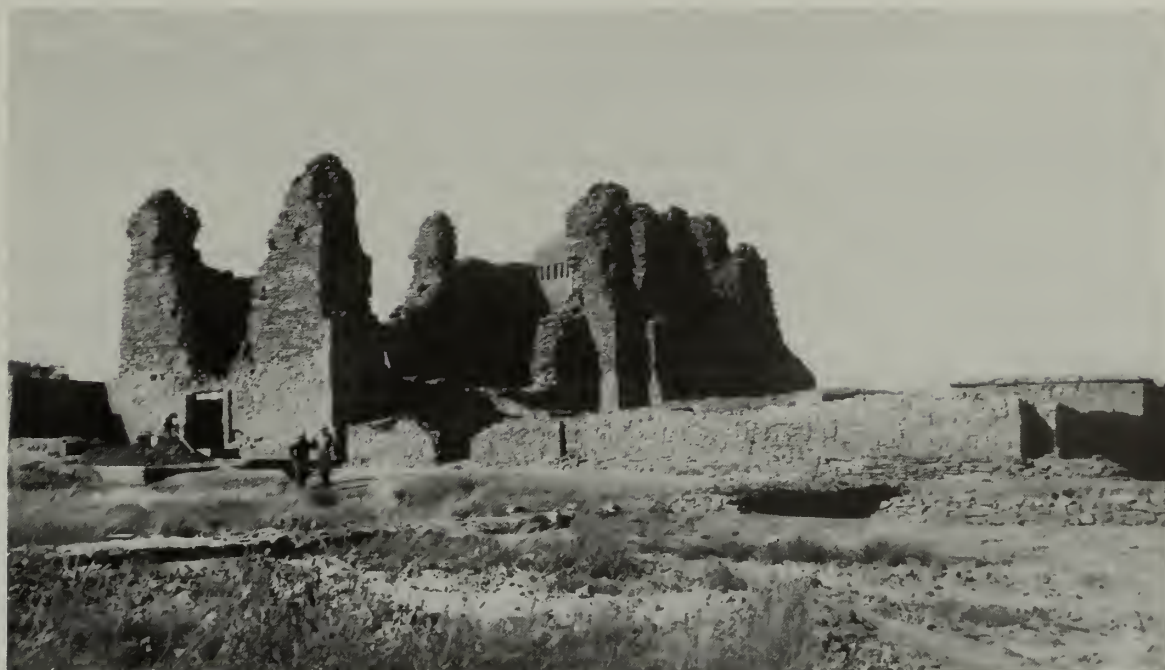
Figure 61. Quarai during the stabilization by Wesley Hurt, October, 1939. At this date the terrace in front of the church had been restored and the north wall of the west transept stabilized and built up to the height of the adjoining tower. The scaffolding has been moved into the apse. One strut of the scaffold is visible at the left edge of the tower at the south side of the east transept. Courtesy Museum of New Mexico, # 6666.

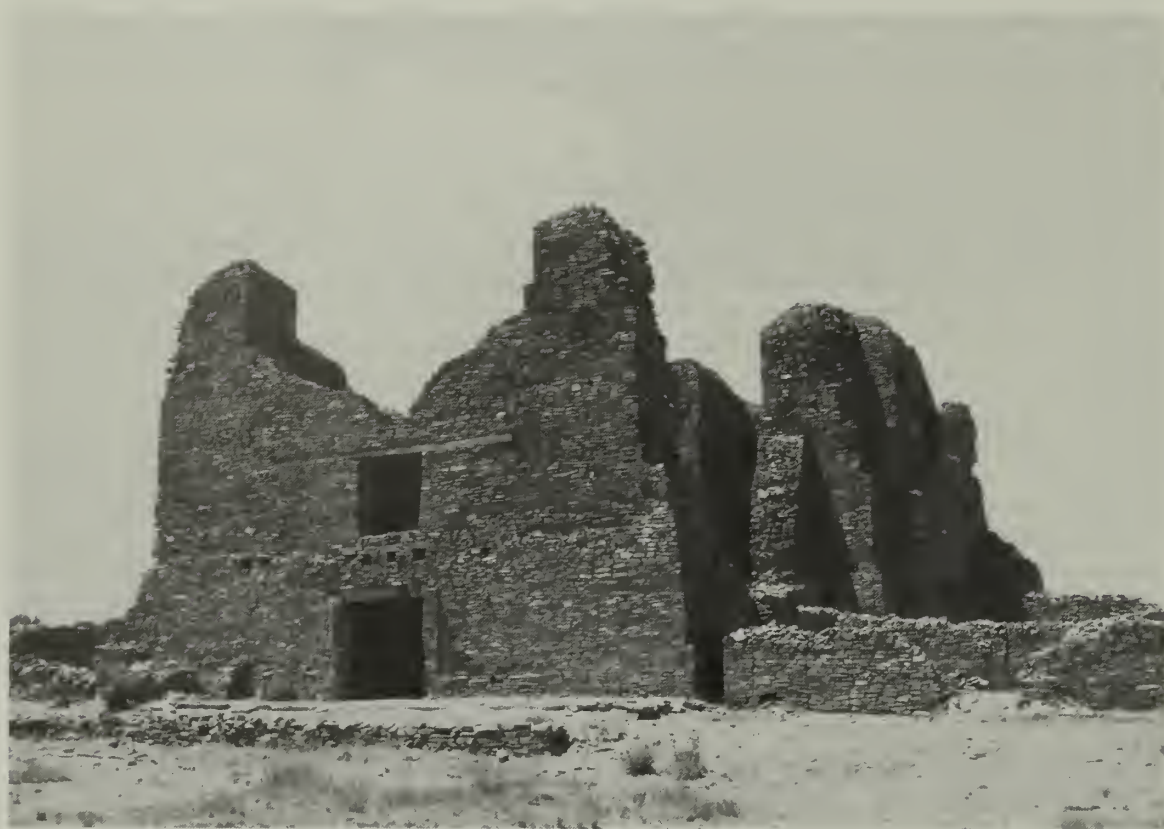
Figure 62. Quarai in 1956, and generally as it appears today. Courtesy Museum of New Mexico, # 6669.

In the church, local sandstone and pencapsula-stabilized mortar were used to cap about fifty percent of the church walls. Only the west nave, west transept, and east nave walls were capped. The wooden lintel beams of the west window, front door and choir window, choir door and sacristy door were coated with pencapsula, as was the surviving white wall plaster high on the inner face of the west transept wall. The treasure-hunter's pit through the apse wall was not repaired.

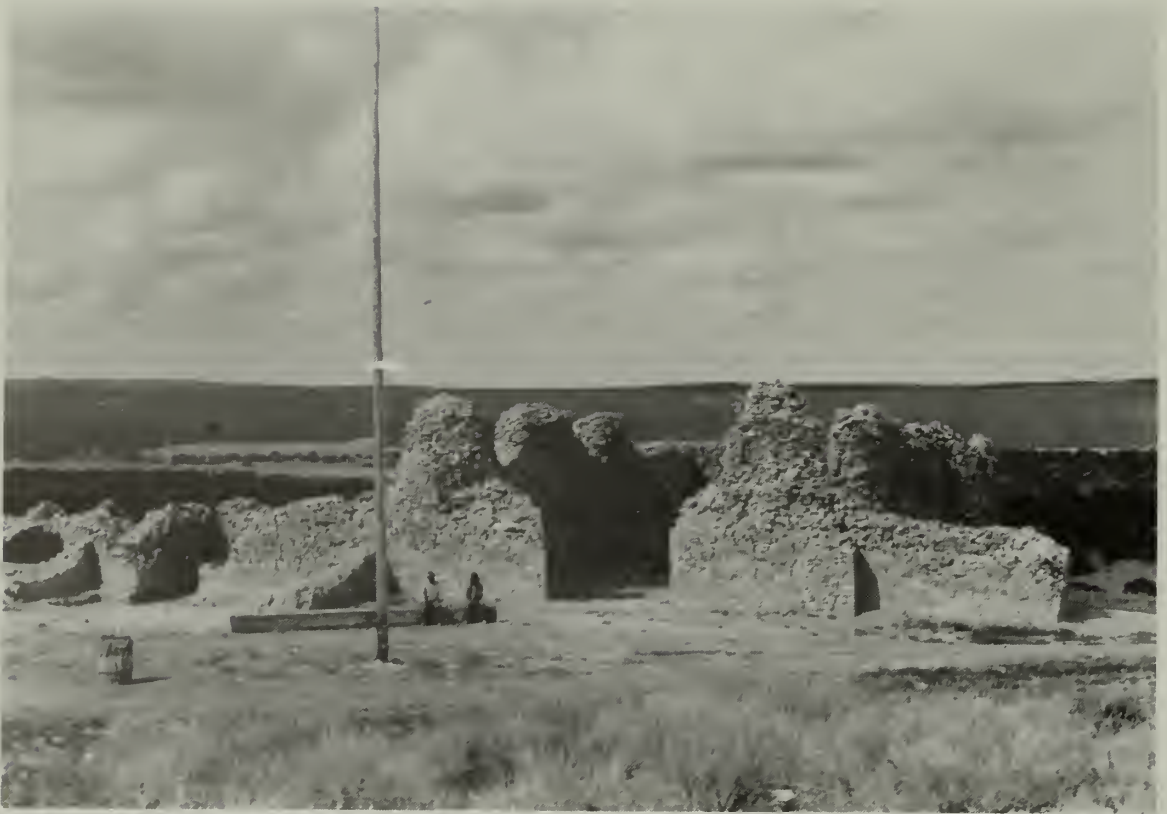
Figure 63. San Buenaventura in the 1940s. The lintle beam has been returned to the site, and is on the ground behind the flagstaff with two people sitting on it. Courtesy National Park Service.
